**ROARING BROOK LAKE DAM  
DEC DAM ID #213-2775  
ENGINEERING ASSESSMENT REPORT**

**Town of Putnam Valley  
Putnam County, New York**

**Woidt Engineering & Consulting, P.C.  
41 Chenango Street, Suite 200  
Binghamton, NY 13901**

**December 26<sup>th</sup>, 2014**

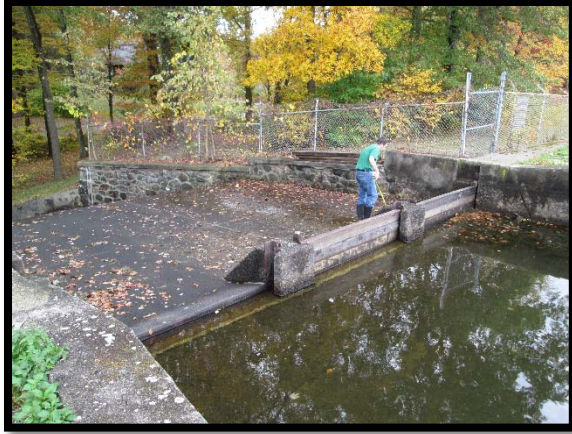
The principal spillway for the dam consists of a 28' wide concrete weir controlled by stop logs. The stop logs (approximately 21" high) are typically installed in the spring and removed in late fall. As such, the maximum summer pool elevation is 16" above a 5" tall concrete lip that serves as the lowest crest elevation of the spillway. An 18" diameter CIP pipe equipped with a gate valve serves as the draw down drain for the lake (see photos, page 2). Typically, the lake is drawn down 4-5 feet below the concrete spillway crest elevation during the winter months. There is no formal auxiliary or emergency spillway. The main dam crest is approximately 450' in length and the dam crest and upstream slopes are armored with heavy placed rip-rap. A saddle dam is located to the east of the main dam and is approximately 150' in length. The saddle dam crest elevation is approximately 2' higher than the main dam crest elevation.

Primary Spillway with stop logs

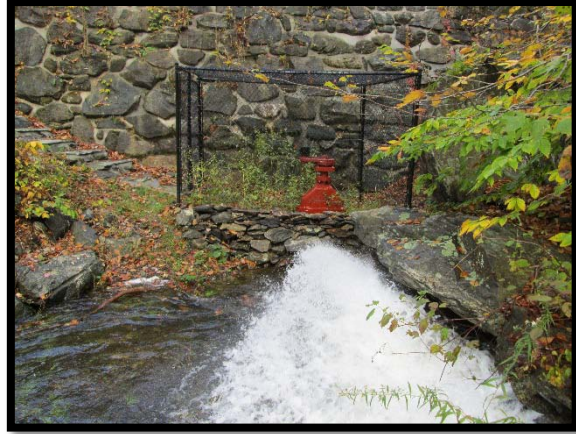
Recently installed low flow drain valve

2. The 18" drawdown drain pipe used to lower the Roaring Brook Reservoir does not have enough capacity to remove 90% of the reservoir volume below the maximum normal summer pool elevation with a 14 day period. Additionally, as noted in the 2014 Inspection Report, a new butterfly valve was installed on the downstream end of the drain pipe, essentially pressuring the outlet pipe through the dam.

2. The location of the control valve at the downstream end of the drain pipe causes concern of potential piping around the outlet pipe since it is now constantly under hydrostatic pressure. It is recommended that further investigations be conducted to determine if the control can be installed at the inlet of the drain pipe.
