**Roaring Brook Lake Water Quality  
and Aquatic Plant Monitoring Report  
2019**

**Prepared for the Town of Putnam Valley, NY,**

**Supervisor Sam Oliverio, August 2020**

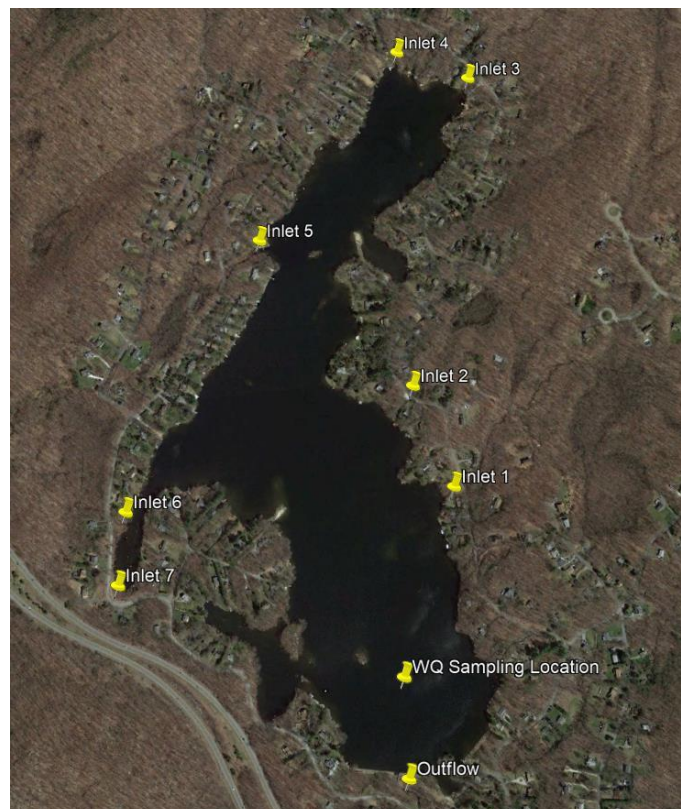
*Figure 1. Location of the in-lake water quality sampling location and prominent inlets sampled in 2019.*

Water clarity is measured at the deepest location (**Figure 1, labeled WQ**) in the lake (N 41.43450° W 73.80624°) using an 8-inch circular disk with black and white alternating quadrants call the Secchi disk. The disk is lowered into the water on the shady side of the boat until it disappears from view using a view scope, then raised until visible again, the average between the depth the disk disappeared and the depth at which it re-appeared is the Secchi depth. Secchi disk water clarity measurements are estimates of light penetration, typically equal to about 15% of the light at the surface. Secchi disk depth has been shown to estimate the amount of phytoplankton and suspended sediments in the water column (Tizler 1988) .

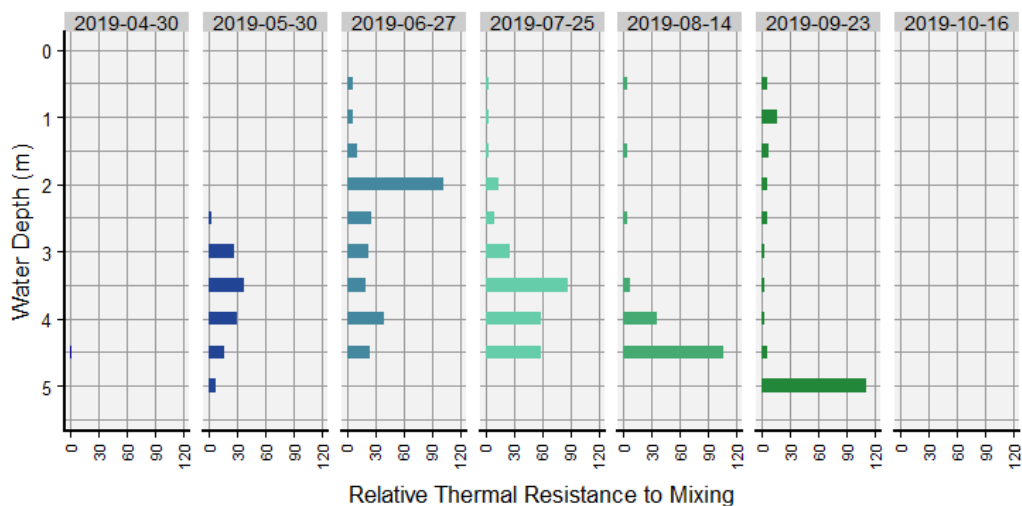
Figure 6. 2019 Relative Thermal Resistance to Mixing (RTRM). Absence of bars in April and October indicate that the lake was fully mixed during this time.

RTRM follows a similar pattern to the temperature profiles, with no resistance to mixing in April and October (Figure 6). From June to September, the depth of the strongest resistance to mixing (the longest bar on any given date in Figure 6) dropped progressively lower as more of the water column warmed.

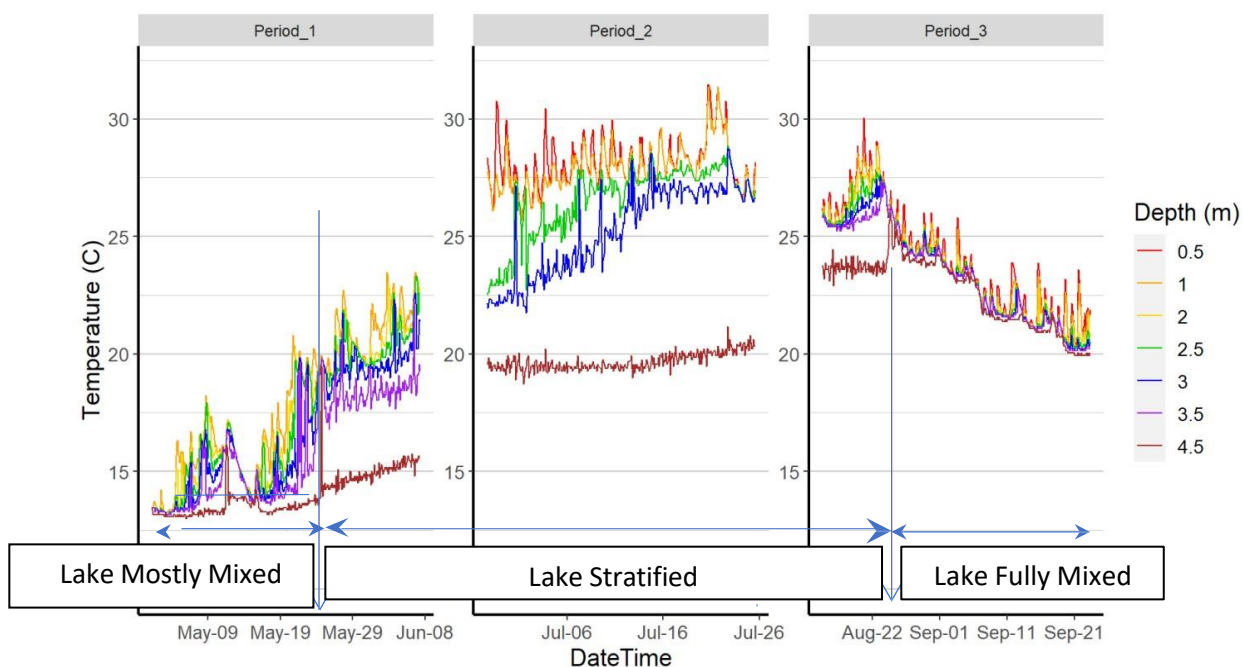
Figure 7. Results of continuous water temperature data loggers in Roaring Brook Lake in 2019.

A suite of water temperature loggers was deployed in the lake at half-meter depth intervals, from top to bottom in the deepest water. The loggers were fixed at the following depth increments: 0.5, 1.0, 2.0, 2.5, 3.0, 3.5, and 4.5 meters. The recorders ran continuously between May 1<sup>st</sup> and Sept 26<sup>th</sup>, however, the receiver crashed due to data overload after about 30 days. The data is shown for each of the three continuous collection periods, Period 1, between May 1<sup>st</sup> and June 10<sup>th</sup>, Period 2, between June 27<sup>th</sup> and July 28<sup>th</sup>, and Period 3, between August 14<sup>th</sup> and September 26<sup>th</sup> (**Figure 7**).

Period 1 shows the lake begins isothermal on May 1<sup>st</sup>, with a turbulent 20 or so days in May when daily gains at the surface were redistributed thorough the water column at night. The lake starts to gain heat at the surface faster than it can be redirected downward on about May 20<sup>th</sup>. After that date, the bottom water temperature separates from all water layers above, from this date on, the water at 4.5 meters is isolated. The data very clearly shows the lake developed initial stratification on May 20<sup>th</sup>. However, between May 20<sup>th</sup> and June 10<sup>th</sup> all water above 4.5 meters was uniformly gaining heat during the day and redistributing the heat during the night but always getting warming. There was one small mixing event on May BLANK, which only lasted 2 hours.

Period 3 shows the lake water at 4.5m remained isolated from waters above until a profound mixing event on August 26<sup>th</sup>. After that date, the whole water column was turbulently mixing. The data very clearly shows how daily heat income at the surface was quickly lost each night with an overall trend toward colder water temperatures each day.

- 1) The lake thermally stratifies at the deep section, with only two instances captured where mixing is occurring after stratification has set up (see temperature logger data graph; **Figure 7**).
- 2) Dissolved oxygen is lost at the bottom of the lake during the summer, starting at the end of May and continuing through the middle of September. The most severe oxygen loss was found during the end of July, with the anoxic boundary located at 3.75 meters.
- 3) This loss of dissolved oxygen has resulted in the release of phosphorus and nitrogen from the sediments during at least late-July to mid-August, probably into September as well.

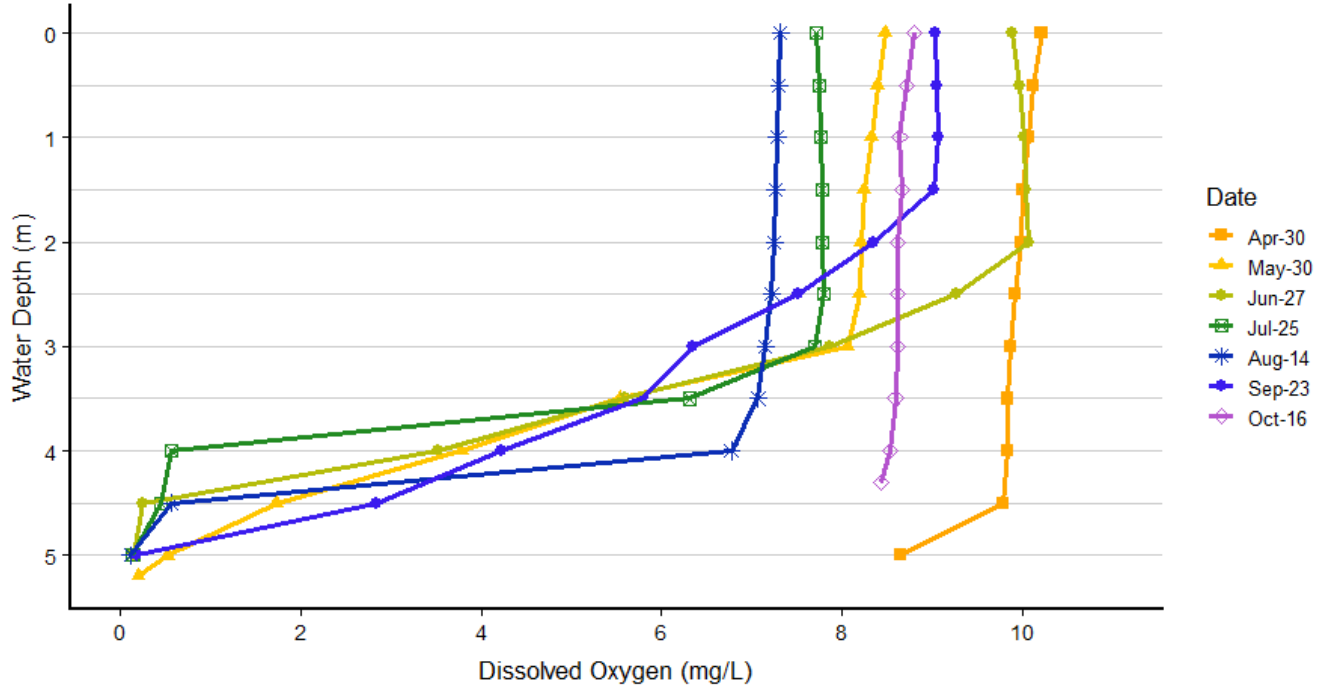
Figure 8. 2019 dissolved oxygen profiles.

The dissolved oxygen (DO) profile data (**Figure 8**) shows the lake had good DO levels in the top 3-4 meters of water. The DO concentrations in this layer decline as the season progresses due to the warmer water naturally holding less DO. However, water below 3-4 meters shows severe DO consumption deflection, meaning profile lines reach the Y axis before getting to the bottom beginning in May.

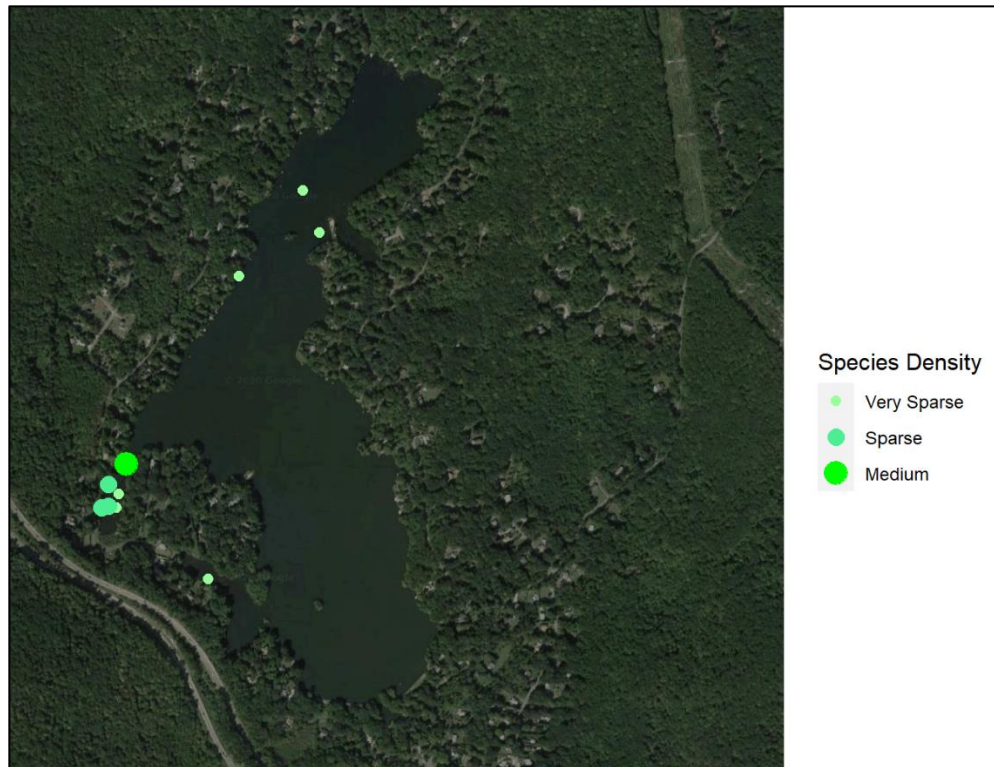
Figure 25. Locations of filamentous algae during the August 2019 survey.

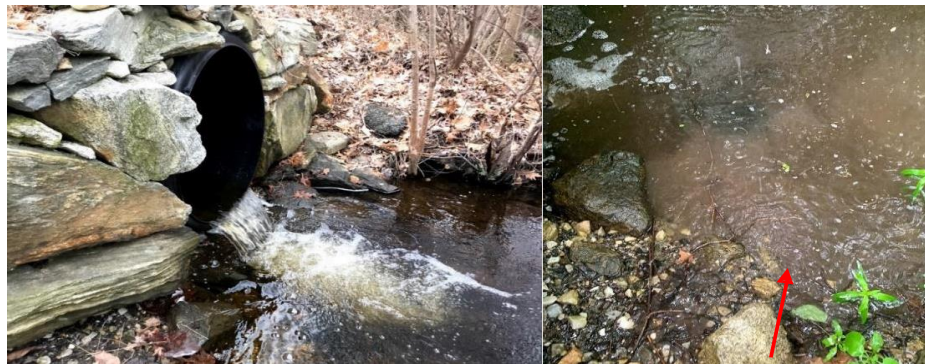
Note the highly turbid water plume in the stream during rain event in June

**Suggested Action:** Continue monitoring, look to mitigate runoff from the immediate north and south sections of Lake Shore Road. Take nutrient samples north of Lake Shore Road.

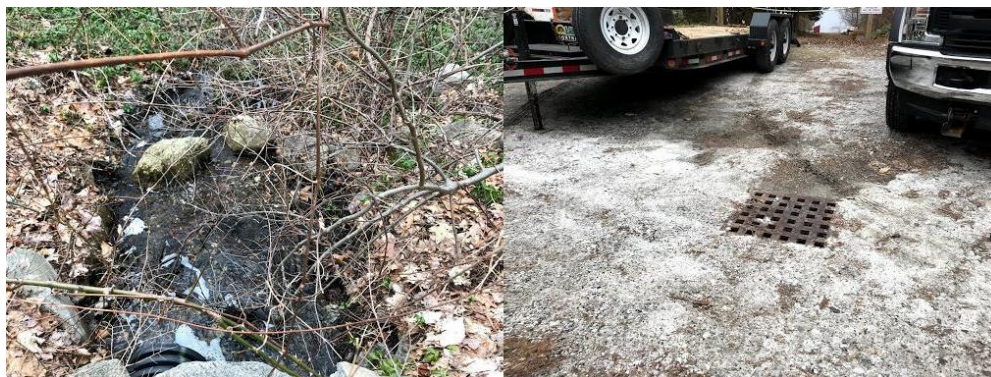
Located on the western side of the lake, north of Holly Street. The stream is ephemeral, flowing until June. Sedimentation is an issue, as the catch basin on the lake-side of the road is covered in sand and loose dirt. During rainstorms, a large amount of that sediment will end up in the catch basin, and eventually make it into the wetland below, filling it in.

**Suggested Action:** Continue monitoring, install a sediment filter at the catch basin. This will help trap sediment and prolong filling in the stream before it enters the lake.

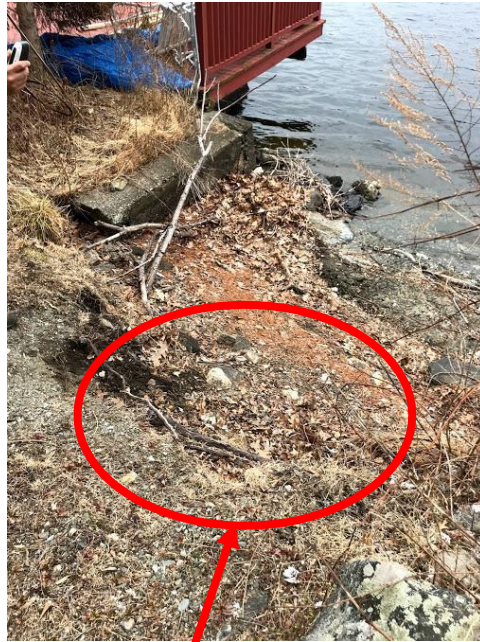
The district access at inlet 2 has a bank that is eroding. High water levels and wave action has carved out a part of the bank which will add more sediment into the lake. The slope of the beach also lends itself to high stormwater flows, especially in early spring, when ground vegetation is not thick and cannot slow down water.

Severe bank erosion is accelerating sediment transport into lake.

**Suggested Action:** Repair this erosion by either grading out the slope or putting some sort of retaining wall (stone or earthen) to limit erosion.

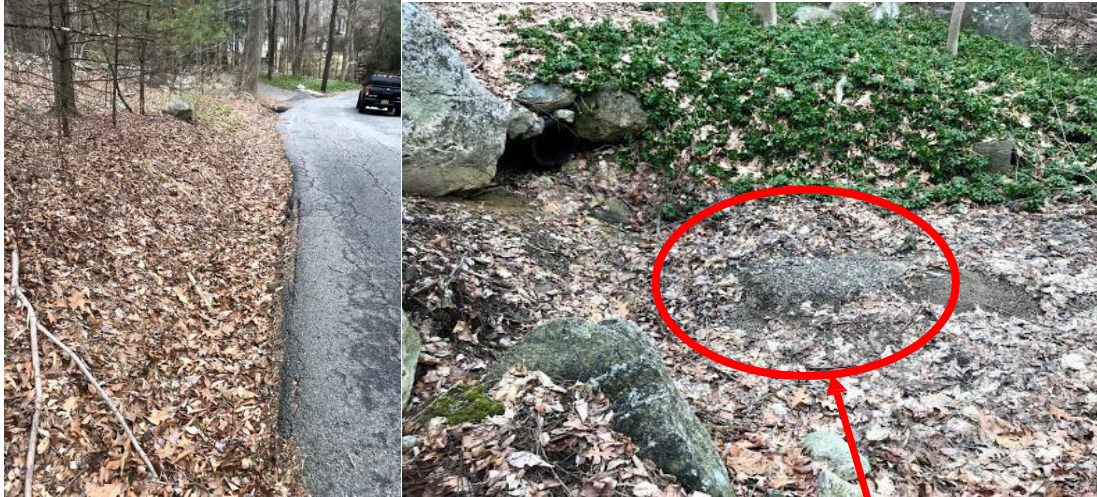
The steep slope at alpine place can create a flume of stormwater rushing down into the two catch basins at the bottom of the street. Nutrient samples taken during a storm event indicate a potentially high load entering the lake (TP: 348 ppb, TN: 1302ppb; **Table 6**).

Accumulation of Sediment in Catch

**Suggested Action:** The catch basin across the street leads into a small dry detention basin before stormwater flows into the lake. Currently, the basin has a significant amount of sediment buildup that can compromise infiltration. This basin should be cleaned out to increase storage capacity.

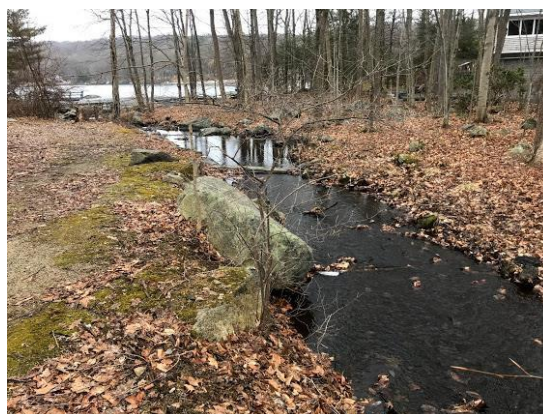
The largest inlet to Roaring Brook Lake is Inlet 5. This inlet also has some of the high nutrient and fecal coliform values. This sub-watershed is the largest of the inlets and contains the highest number of houses so higher nutrient and fecal coliform concentrations are expected. The stream becomes quite severely turbid during storm events, becoming muddy only a few hours after rainfall.

**Suggested Action:** Continue monitoring, the upper end of the inlet should be added to monitoring, as that can help narrow down the source of high nutrients and fecal coliform. The stream should also be walked if possible, to identify areas prone to erosion.

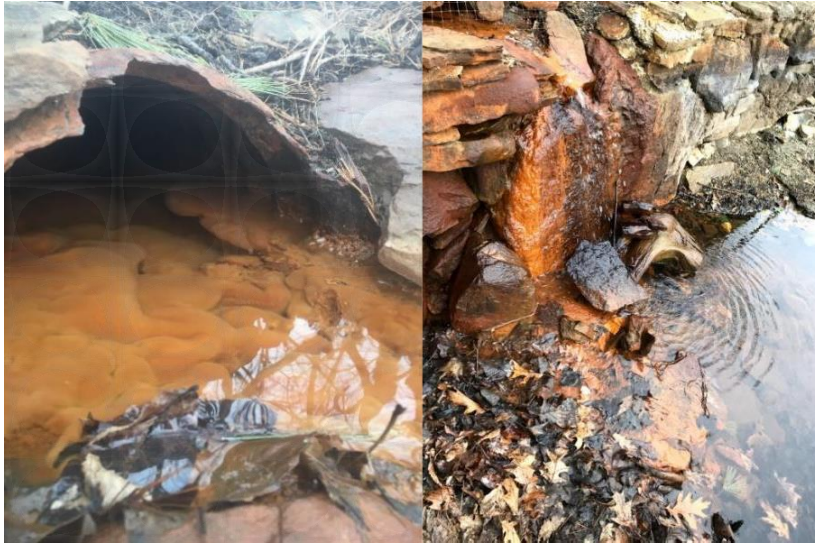
A pipe with water containing iron flocculant. Sources of the iron in the water should be considered. Water with either high nitrogen or phosphorus concentrations was found flowing out of the pipe on three separate occasions (**Table 6**).

**Suggested Action:** Contact homeowner where the pipe is located to discuss possible remediation actions.

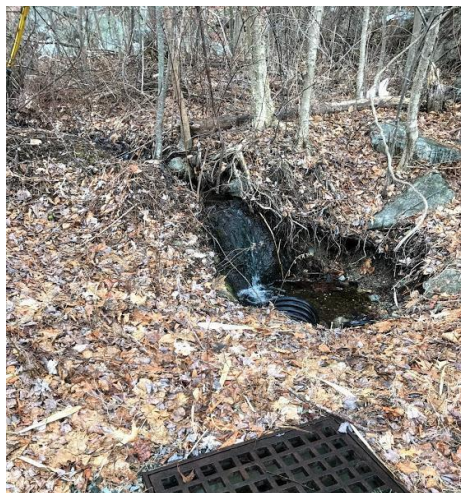
Inlet 7 drains part of the Taconic Parkway and therefore may have a significant number of constituents that we don't routinely test for, including heavy metals, and volatile organic carbon compounds. runoff. High fecal coliform and nitrogen were documented in May. There is a settling wetland before the stream crosses the road.

**Suggested Action:** Continue monitoring the stream. Inspect the settling wetland above the road to look at sediment deposition and perform maintenance if necessary.
